DEPARTMENT OF TRANSPORTATION**DIVISION OF ENGINEERING SERVICES**

Contract #: 04-0120F4Cty: SF/ALA Rte: 80 PM: 13.2/13.9File #: 13.28**WELDING INSPECTION REPORT****Resident Engineer:**Pursell, Gary**Address:** 333 Burma Road**City:** Oakland, CA 94607**Report No:** WIR-005273**Date Inspected:** 28-Jan-2009**Project Name:** SAS Superstructure**OSM Arrival Time:** 1300**Prime Contractor:** American Bridge/Fluor Enterprises, a JV**OSM Departure Time:** 2100**Contractor:** Oregon Iron Works Clackamas, Or.**Location:** Clackamas, Oregon**CWI Name:** See below**CWI Present:** Yes No**Inspected CWI report:** Yes No N/A**Rod Oven in Use:** Yes No N/A**Electrode to specification:** Yes No N/A**Weld Procedures Followed:** Yes No N/A**Qualified Welders:** Yes No N/A**Verified Joint Fit-up:** Yes No N/A**Approved Drawings:** Yes No N/A**Approved WPS:** Yes No N/A**Delayed / Cancelled:** Yes No N/A**Bridge No:** 34-0006**Component:** Hinge K Pipe Beams**Summary of Items Observed:**

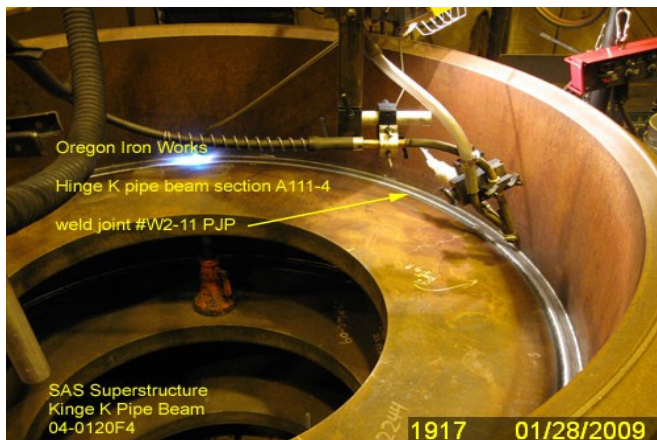
The following digital photograph below illustrates observation of the activities being performed.
